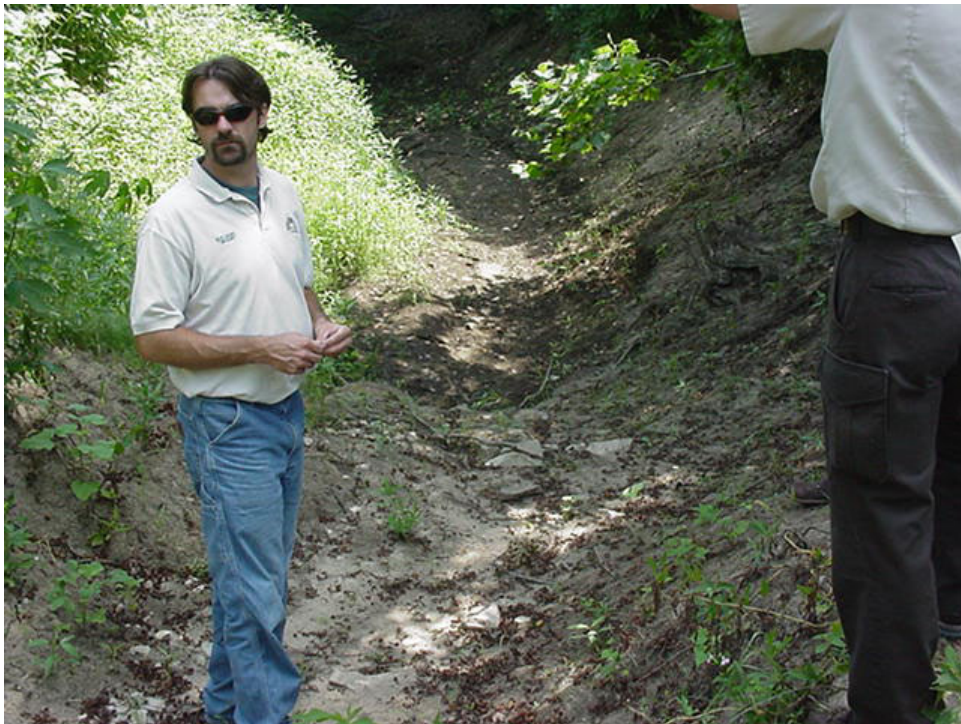
Photo 6: Looking East – Existing CMP drainage/washed out access road.

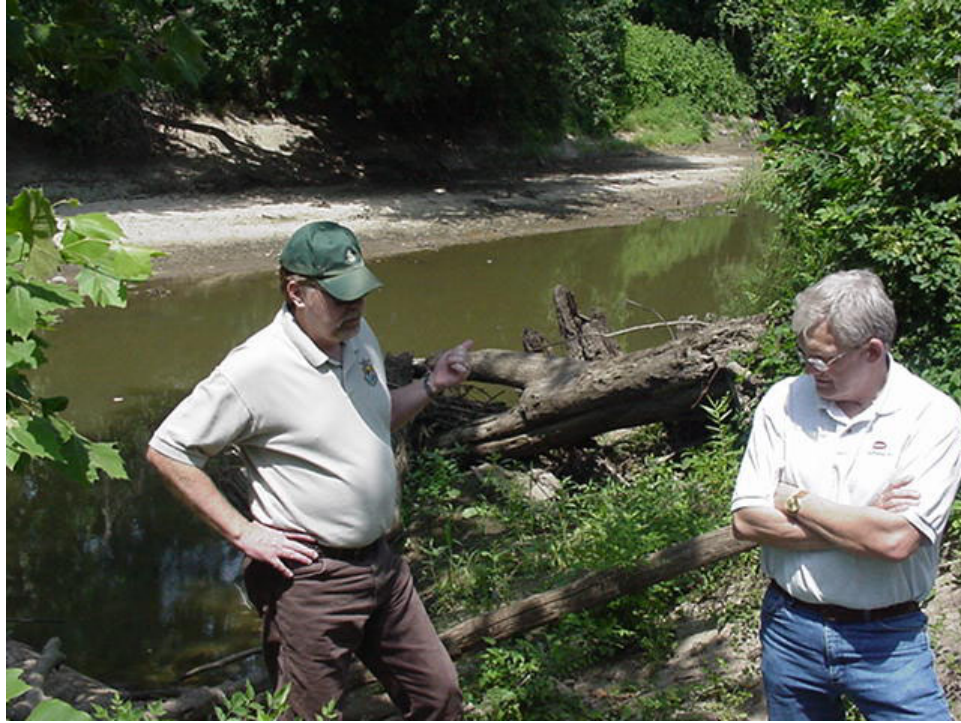
Photo 7: Looking West - Existing CMP drainage/washed out access road.

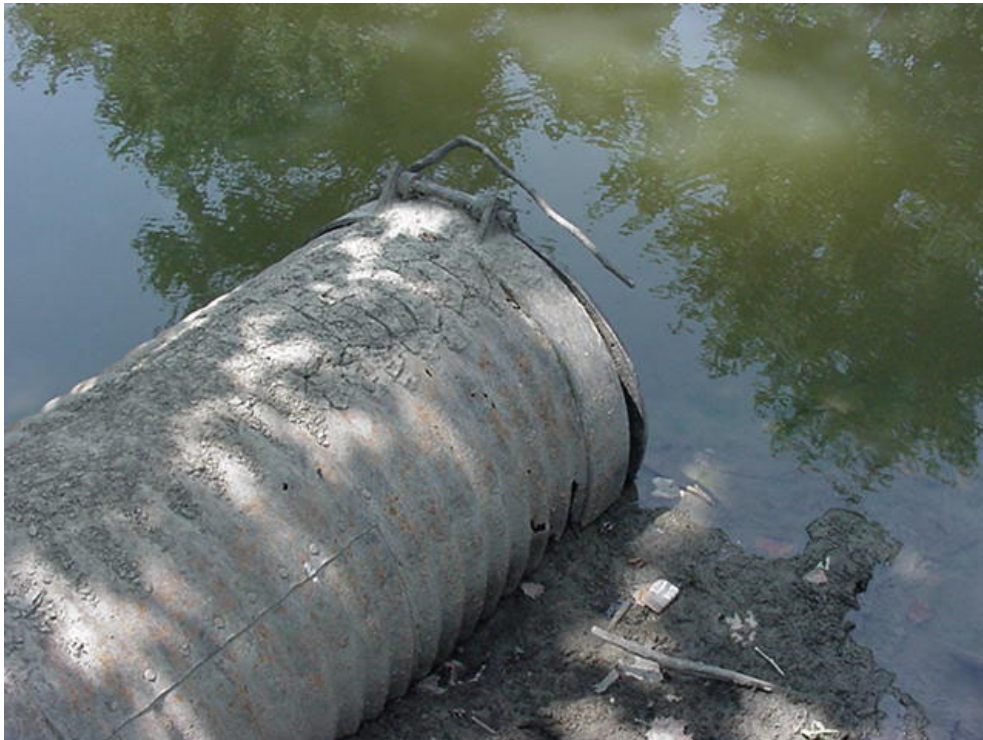
Photo 8: Existing CMP

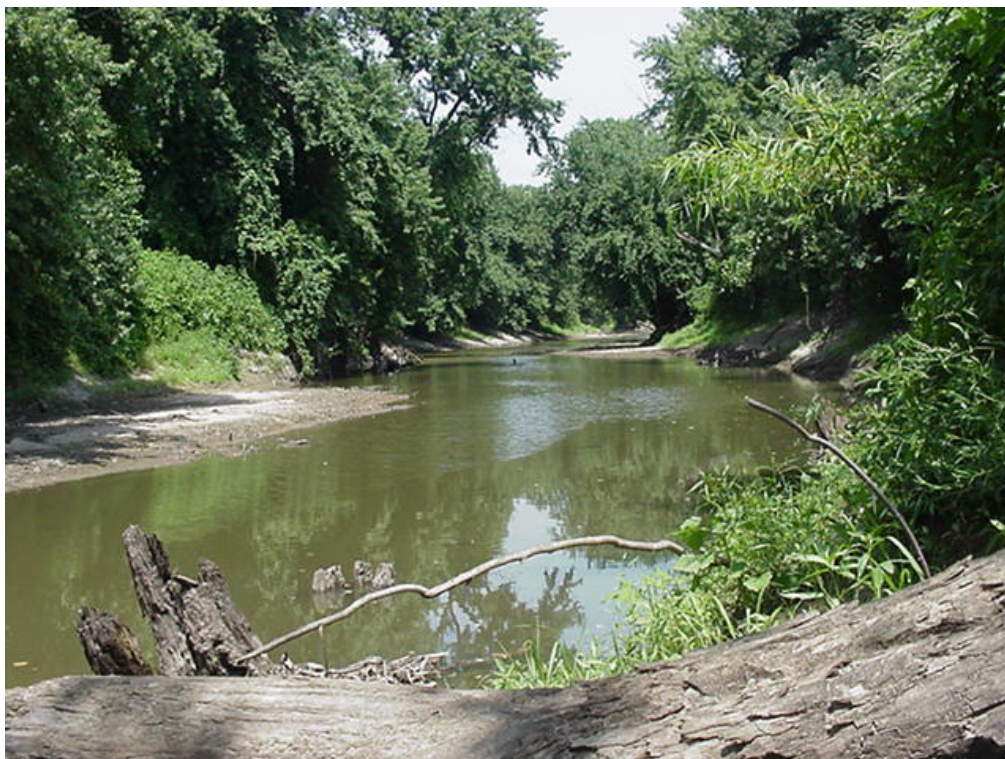
Photo 9: Looking Upstream of Fox River at existing CMP location.

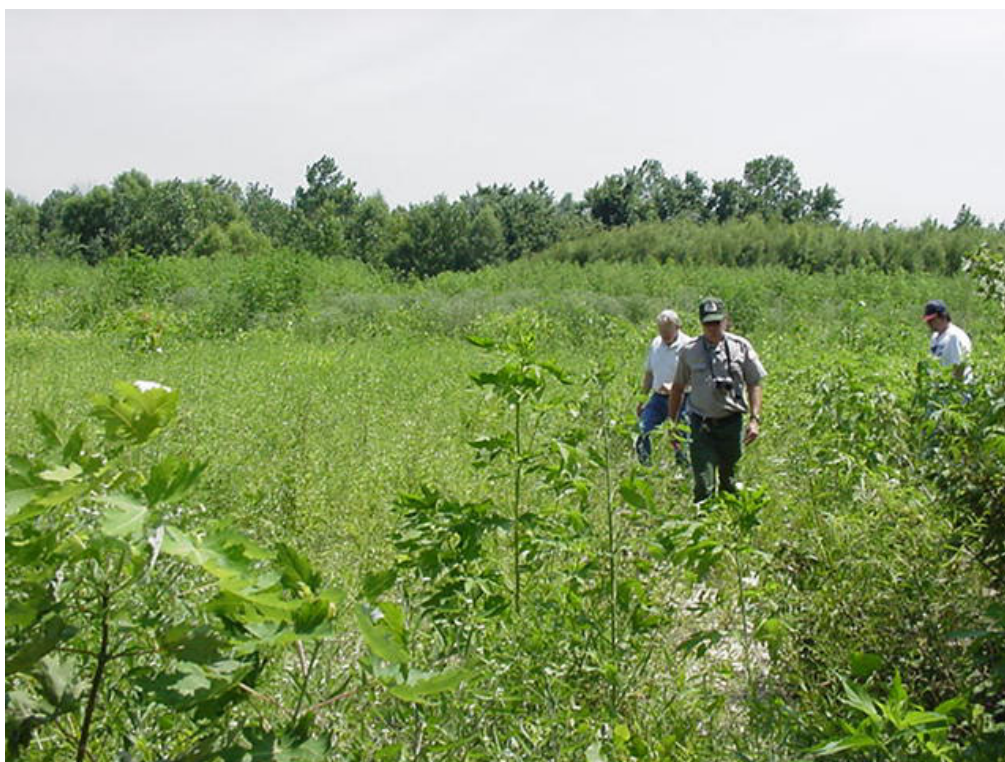
Photo 10: Looking West – Location where earth was built up to prevent Fox River overflowing in a westward direction during high water events. It is speculated by Dave Ellis that this overflow is what causes the erosion at the existing CMP site downstream.

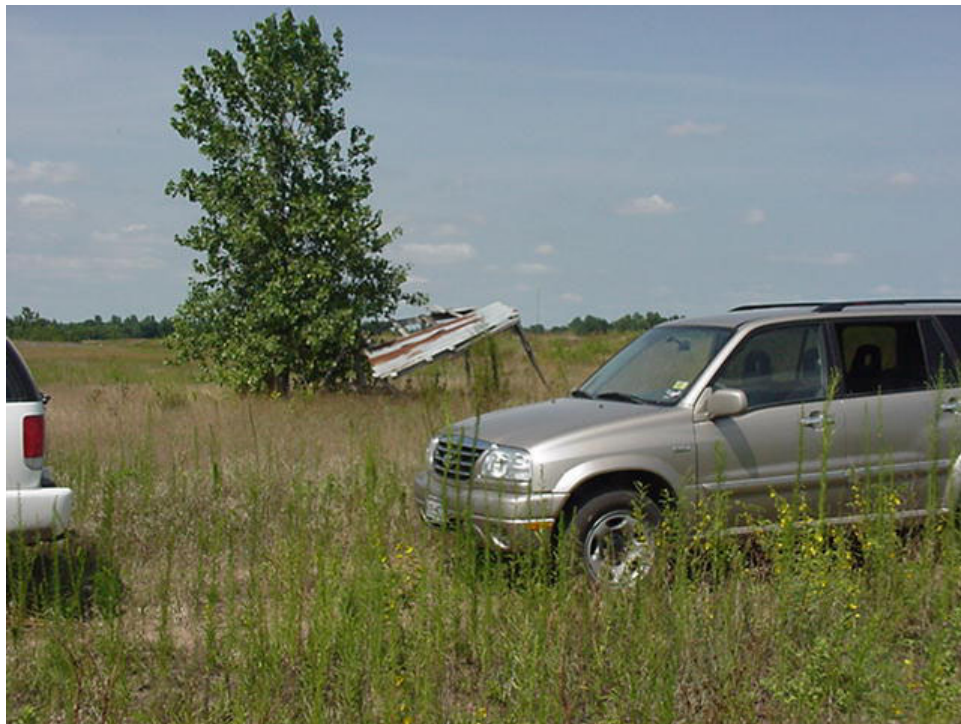
Photo 22: Logsden Tract – abandoned well

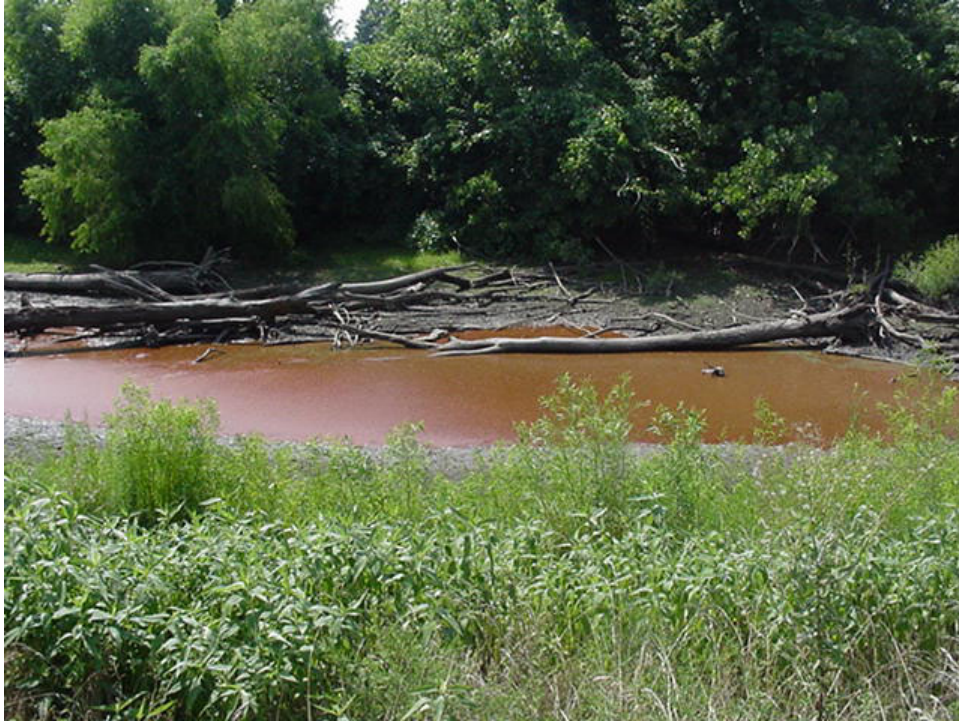
Photo 25: Water on west side of levee just before right turn off of levee onto farm road. Water had an unusual reddish tint to it.
